Inspection Report

Property Address:
1209 Godwin Ave
Norfolk Va 23455

Keff/Spec LLC

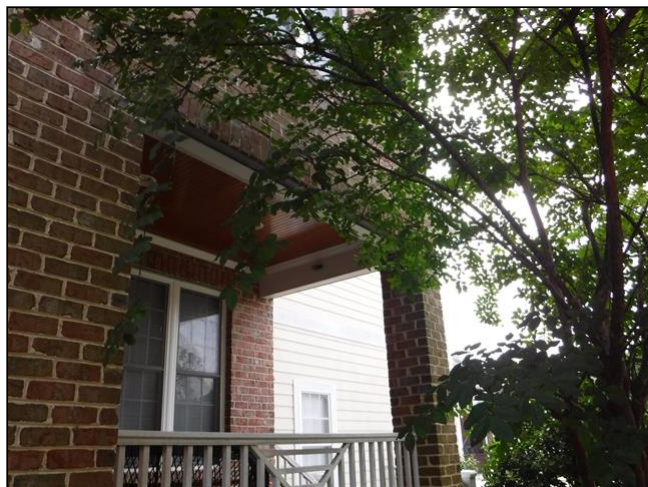
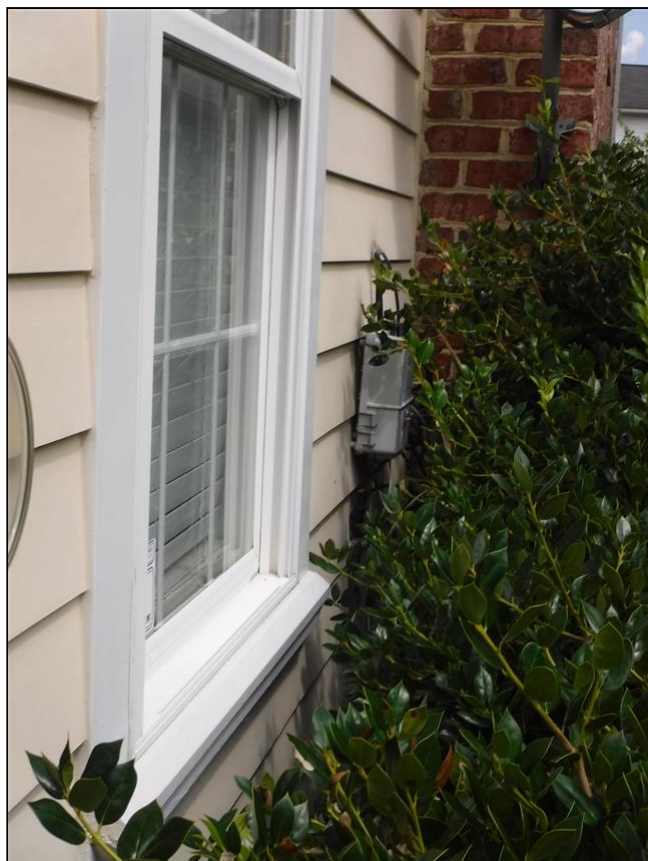
1.0 Item 1(Picture)

(1) The roof covering was visually inspected from the ground and from inside the attic . This is a 30-35 year roof system that is approx. 12 years old , This roof is in good condition.. A qualified contractor should inspect and repair as needed.

(2) The tree limbs that are in contact with roof/siding or hanging near roof/siding should be trimmed. Smaller tree limbs that rub against the roof/siding can cause damage to the building over time.

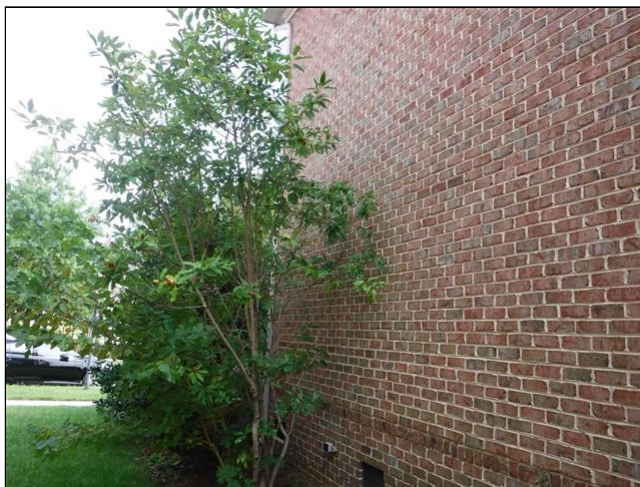
1.0 Item 2(Picture)

1.0 (2) The tree limbs that are in contact with roof/siding or hanging near roof/siding should be trimmed. Smaller tree limbs that rub against the roof/siding can cause damage to the building over time.

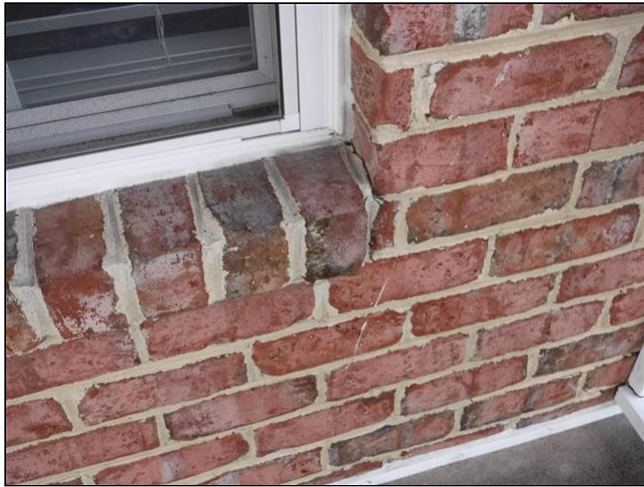
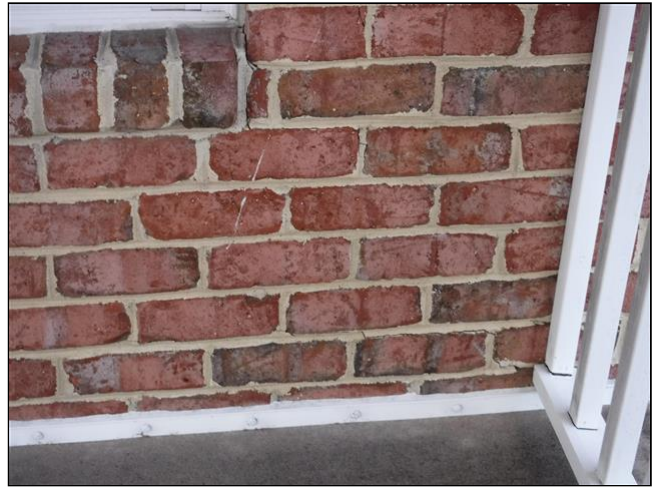
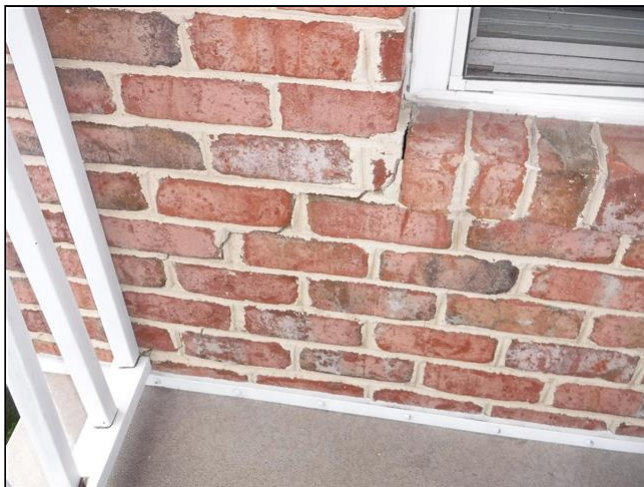
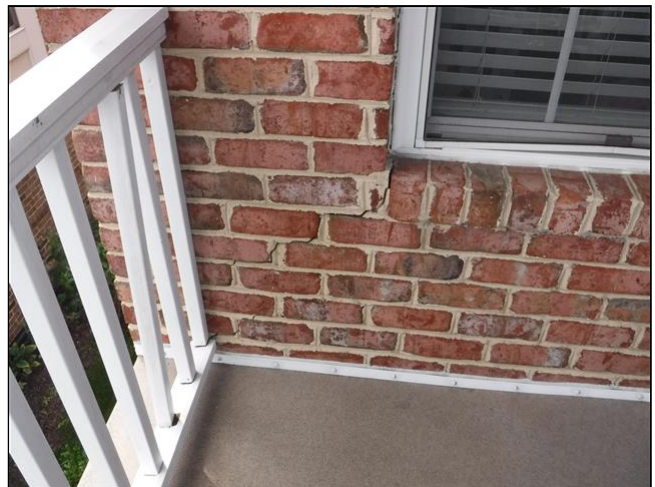
2.0 Item 1(Picture)

The Brick siding at the front of home (around two windows on second floor balcony) has/have a medium crack in mortar joint and brick. This does not appear to be a structural issue . Suggest having these areas "pointed up " and monitoring for further cracks or failing mortar ..

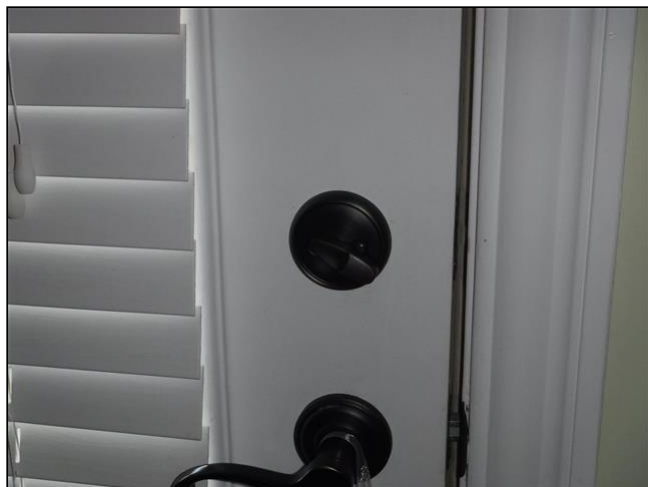
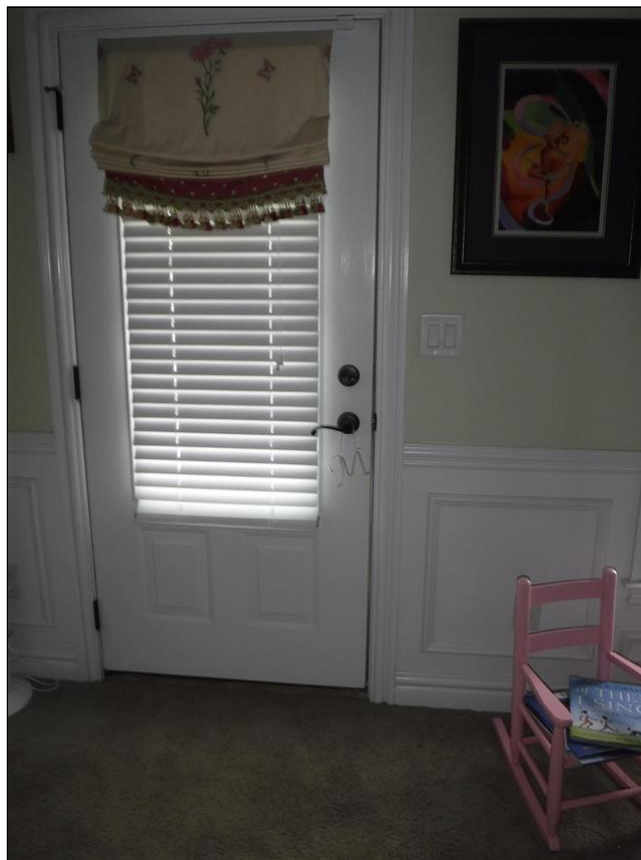
2.1 Item 1(Picture)

(1) The entry door at front upper balcony of home dead bolt and/or door knob does not latch properly and reveals daylight when latched at areas missing weather-stripping. This can cause some heat loss in winter and loss of cool air in summer if not corrected. A qualified contractor should inspect and repair as needed.

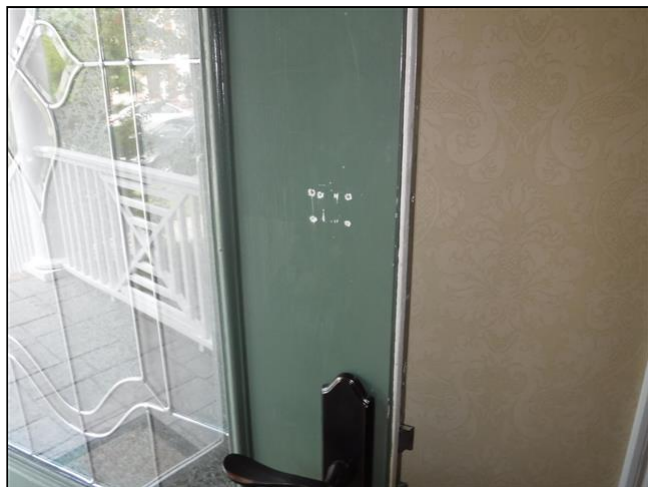
2.1 Item 3(Picture)

(2) The main entry door has small holes from a pad lock . This is a maintenance issue and is for your information. A qualified contractor should inspect and repair as needed.

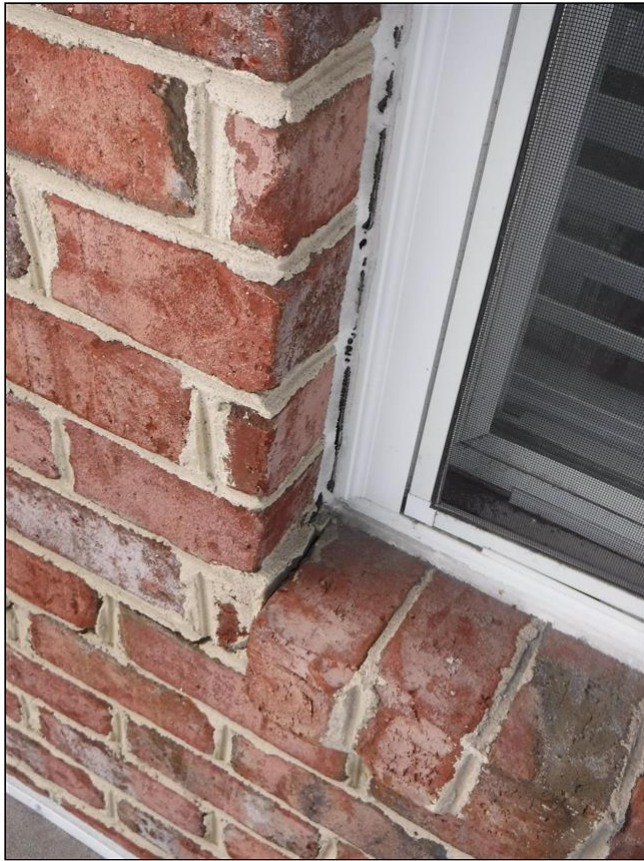
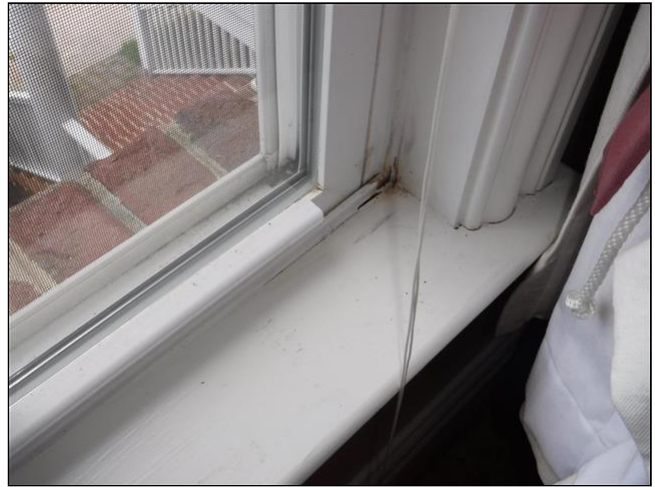
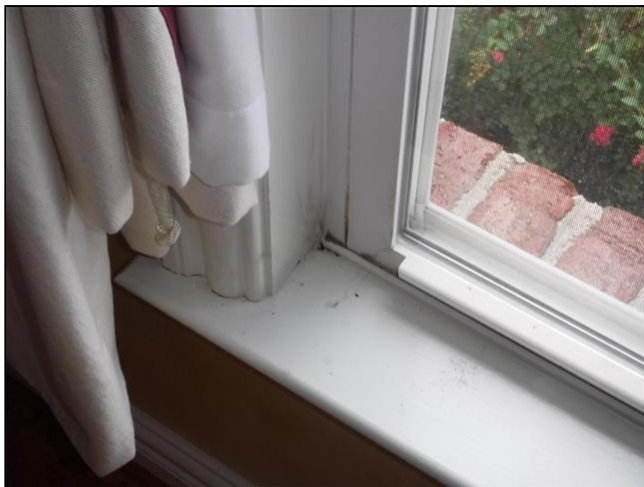
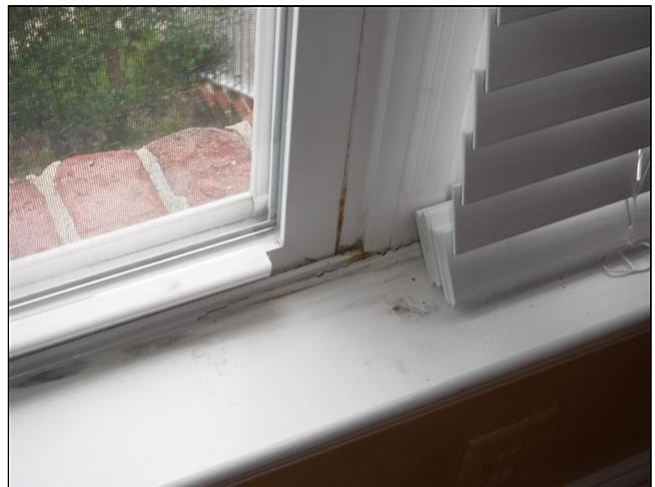
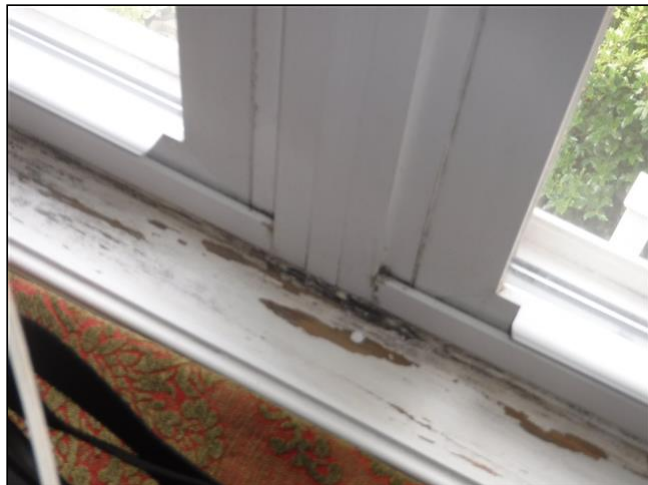
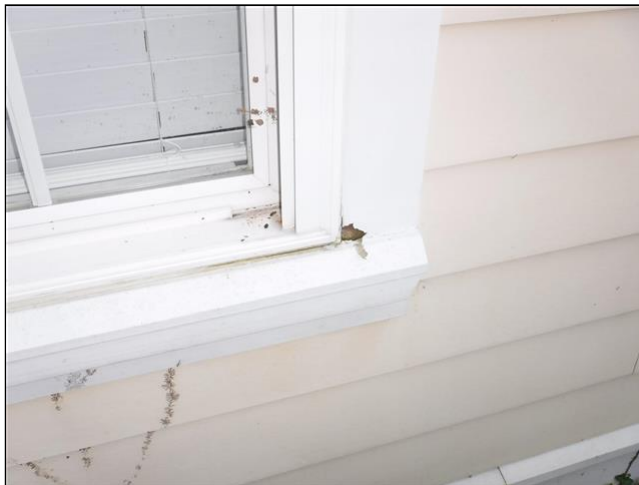
2.2 Item 1(Picture)

(1) The window frames Show signs of water intrusion at at least 4 windows in the home .Windows should be resealed where they meet the exterior siding and or trim . Further deterioration may occur if not repaired. A qualified contractor should inspect and repair as needed.

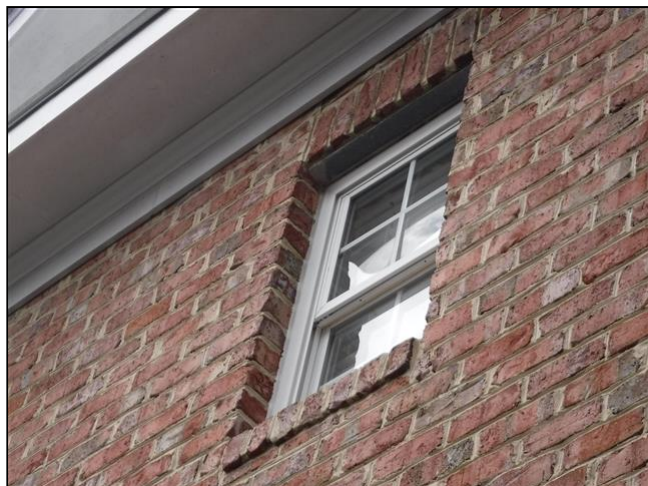
2.2 Item 7(Picture)

(2) The screen(s) is missing at left side (facing front) at laundry room . This is a maintenance issue and is for your information. A qualified contractor should inspect and repair as needed.

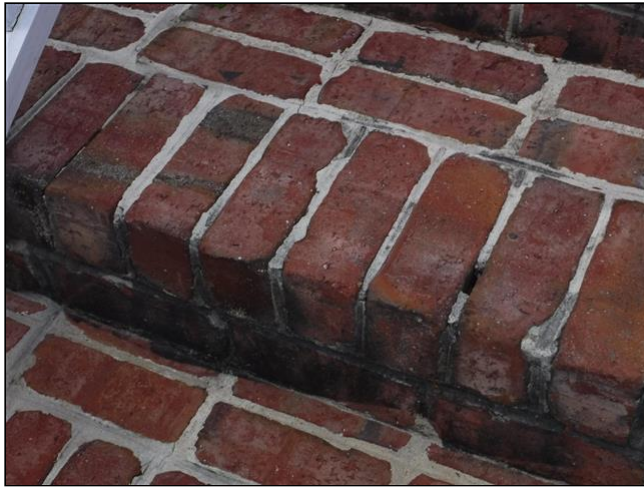
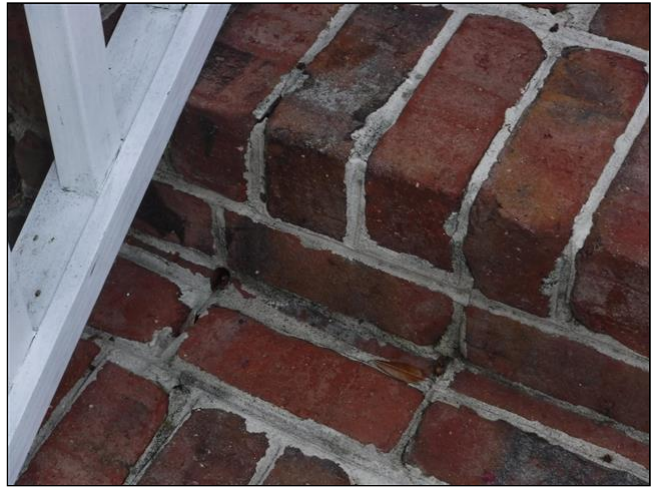
2.3 Item 1(Picture)

(1) The brick steps on the covered porch at the front of home have/has cracked loose or missing mortar. Further deterioration can occur if not properly repaired or replaced.. Suggest a qualified mason "point up " these areas to keep moisture from damaging the steps.

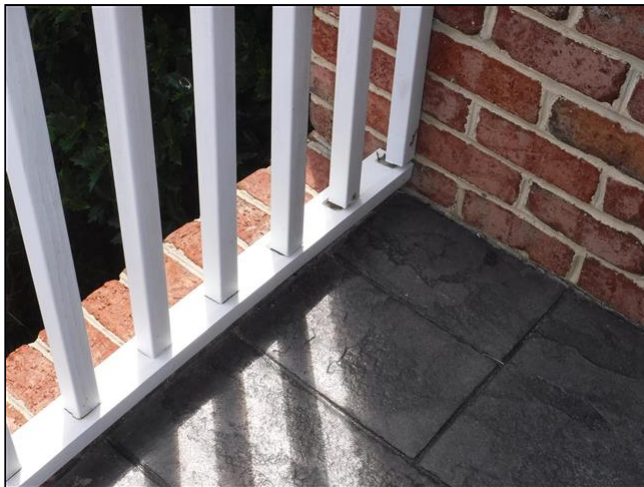
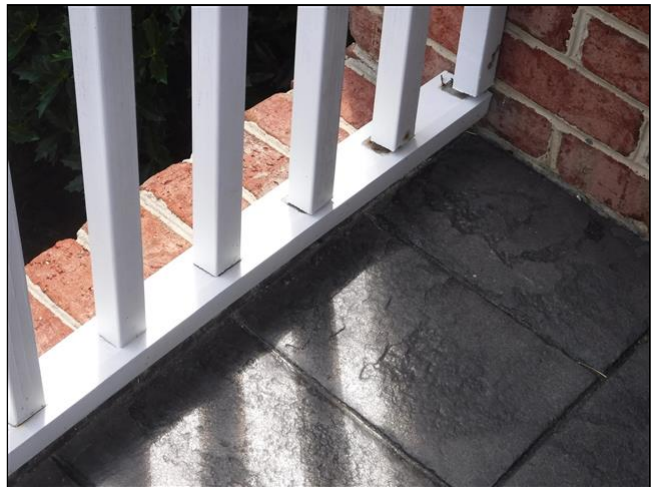
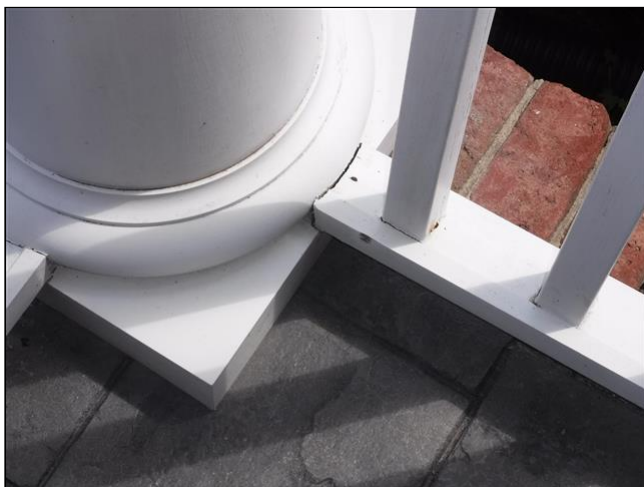
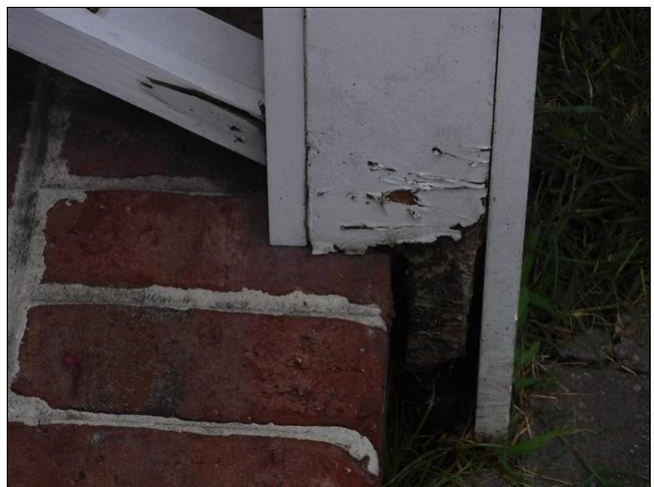
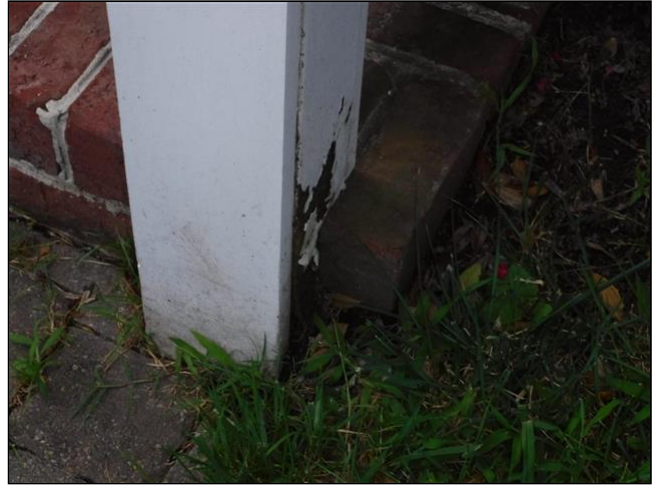
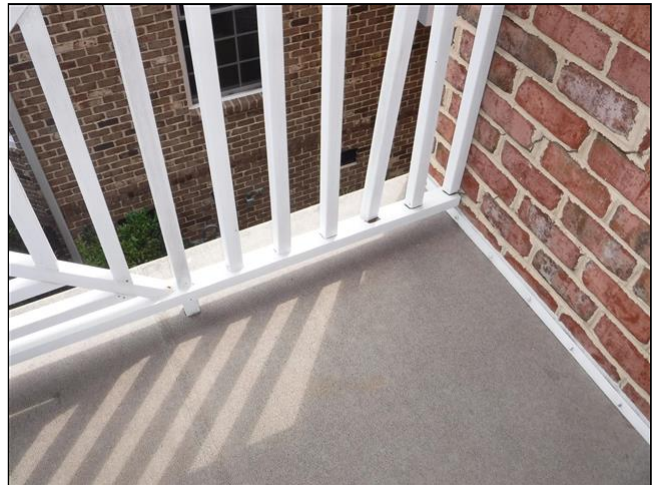
2.3 Item 3(Picture)

(2) The hand/guard rails for the front porch , steps, rear patio and upper balcony are deteriorated in areas and have loose or missing components . Further deterioration can occur if not properly repaired or replaced. A fall or injury could occur if not corrected. A qualified contractor should repair or replace as needed.

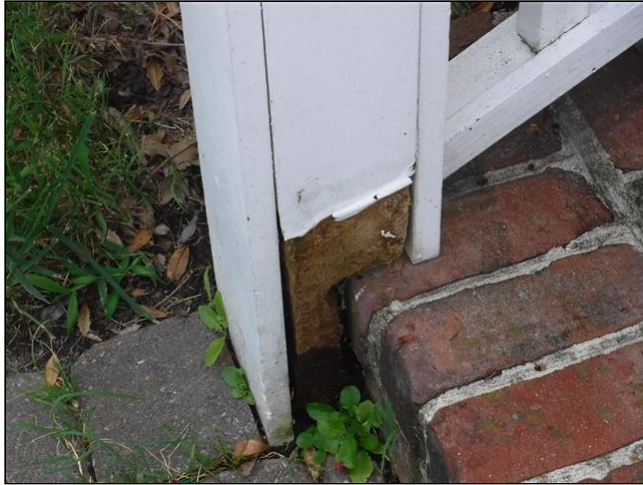
2.3 Item 7(Picture)

2.3 (2) The hand/guard rails for the front porch , steps, rear patio and upper balcony are deteriorated in areas and have loose or missing components . Further deterioration can occur if not properly repaired or replaced. A fall or injury could occur if not corrected. A qualified contractor should repair or replace as needed.

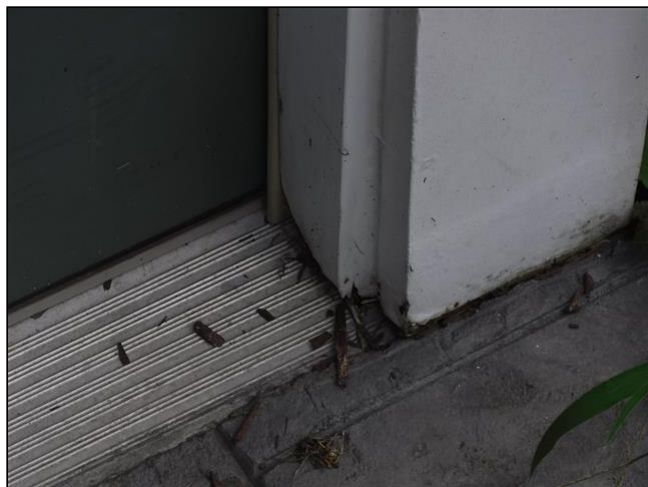
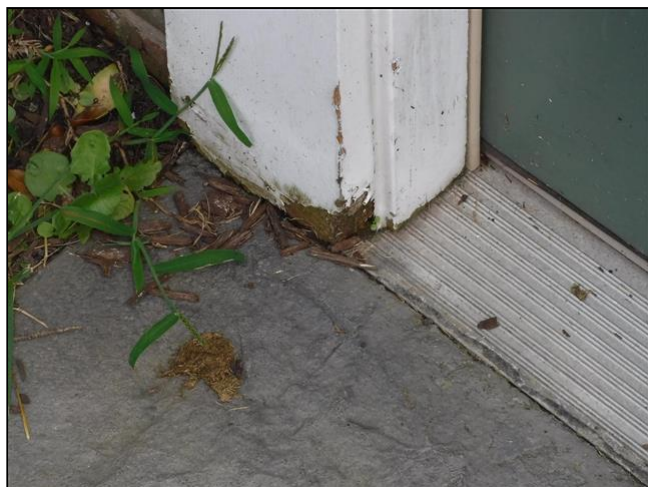
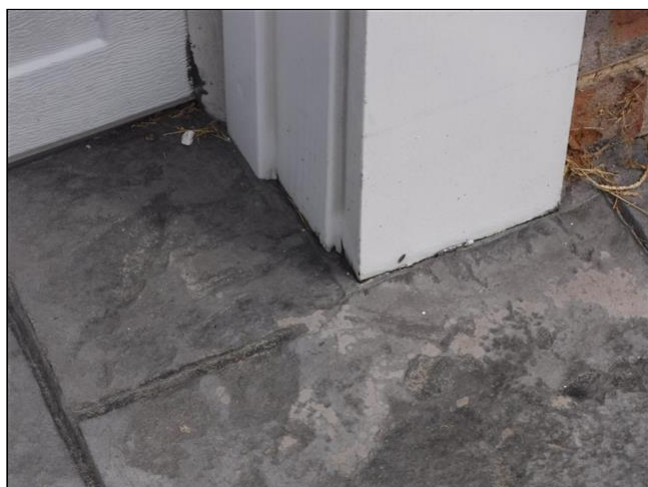
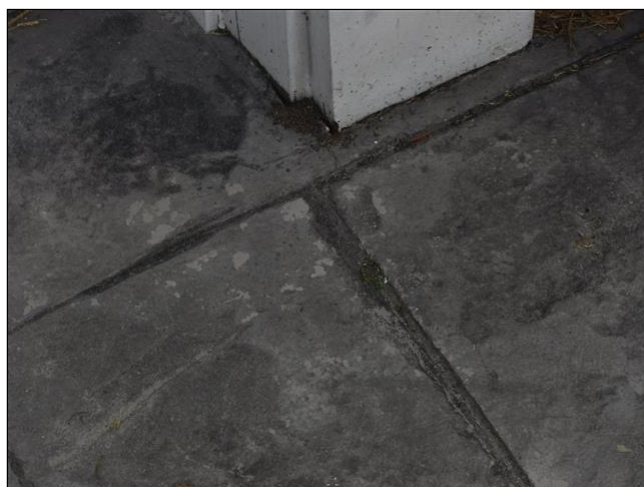
3.3 Item 1(Picture)

(1) The Both garage doors and Entry door to the garage from the outside Trim/brick mold at the rear of home and right side (facing front) shows signs of severe deterioration of the door and jambs. This is a maintenance issue and is for your information. A qualified contractor should inspect and repair as needed.

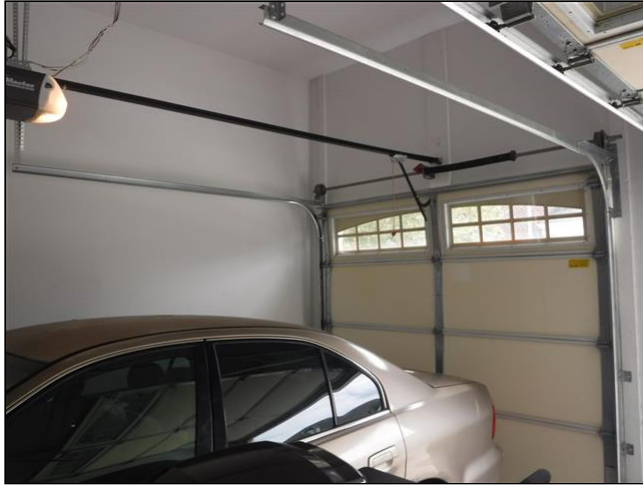
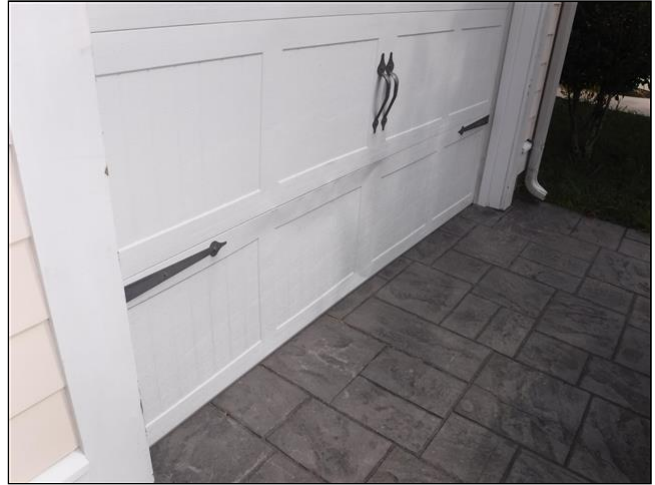
3.3 Item 7(Picture)

(2) The garage door (left side) at the rear of home .Has been damaged at bottom panels . This door also could use track adjustment . This is a maintenance issue and is for your information. A qualified contractor should inspect and repair as needed.

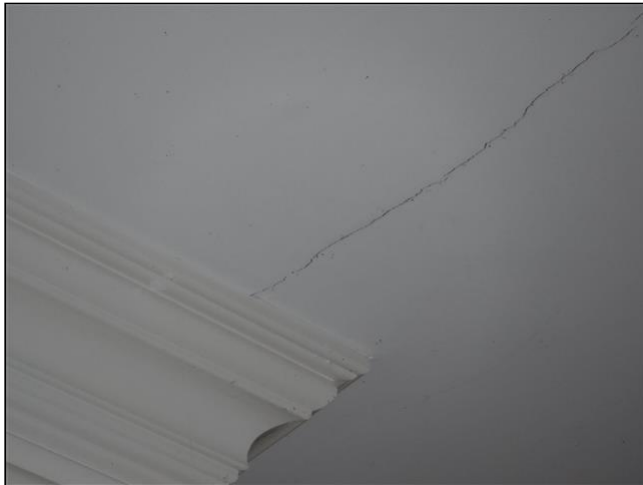
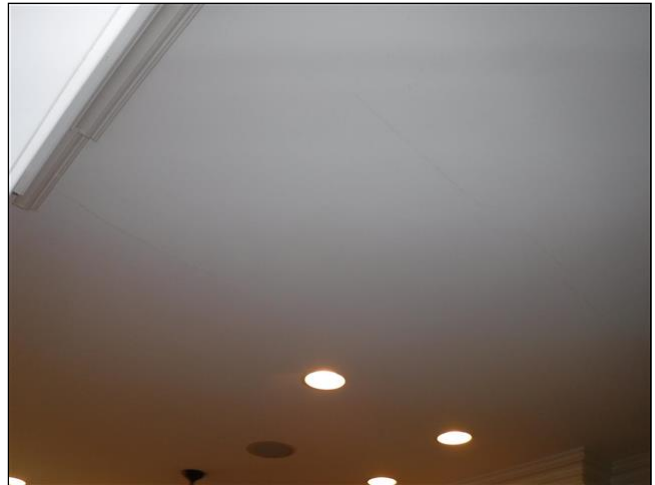
4.0 Item 1(Picture)

The Sheetrock Plaster on the ceiling has two large cracks at the Kitchen. Dining Room. This is more of a cosmetic issue than a structural one. A qualified contractor should inspect and repair as needed.

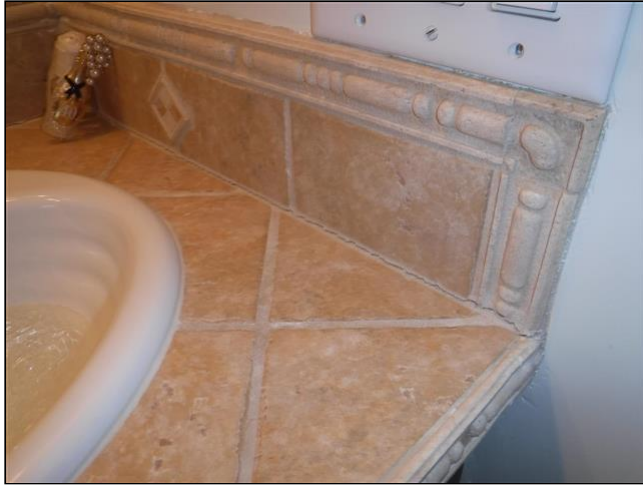
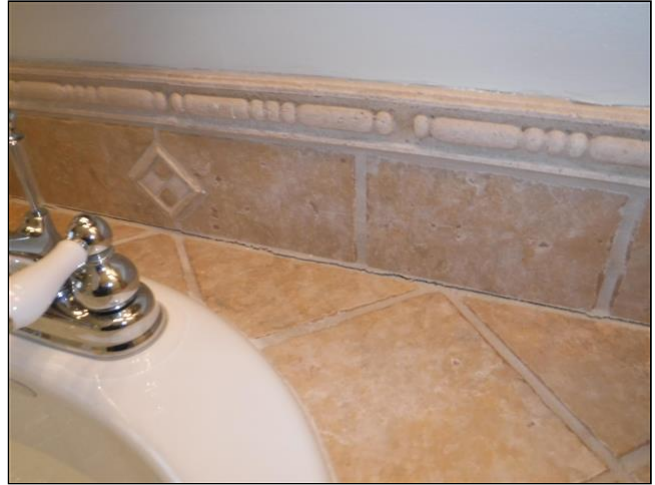
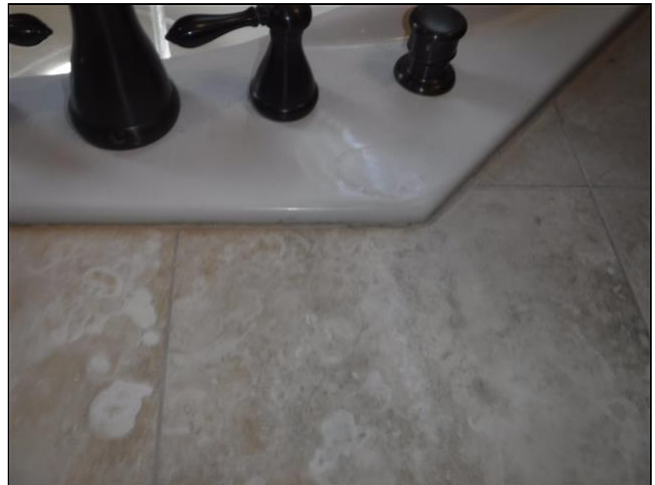
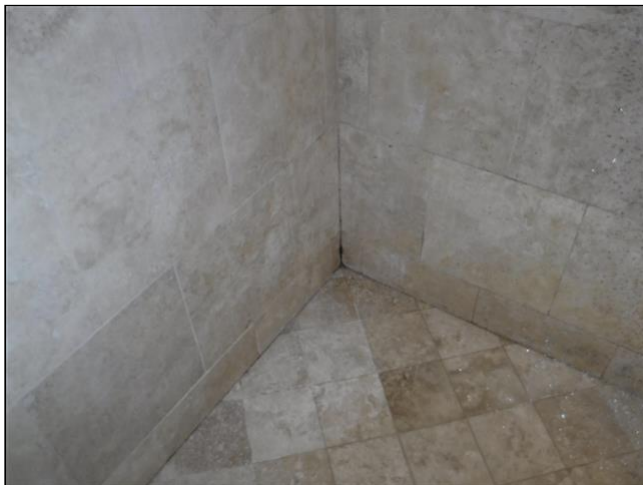
4.1 Item 1(Picture)

(1) The Tile surround at bathtub and Tile surround at shower on the wall and counter tops have, has several hairline cracks at the master bath and hall bath. While this damage is cosmetic, it needs to be repaired. A qualified contractor should inspect and repair as needed.

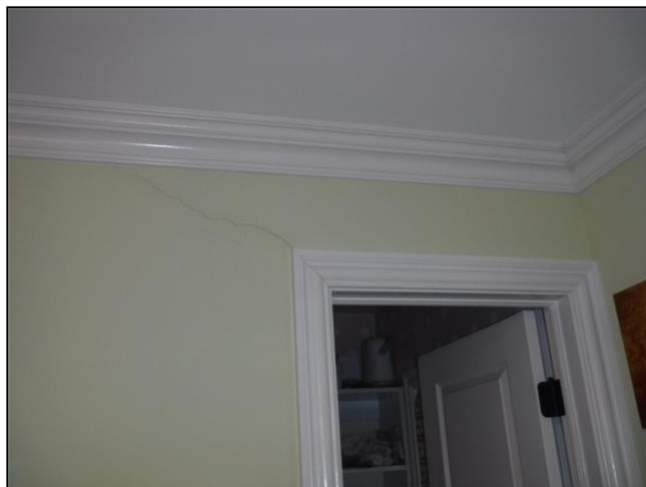
4.1 Item 6(Picture)

(2) The sheetrock plaster on the wall has a large crack at the front left bedroom . While this damage is cosmetic, it needs to be repaired. A qualified contractor should inspect and repair as needed.

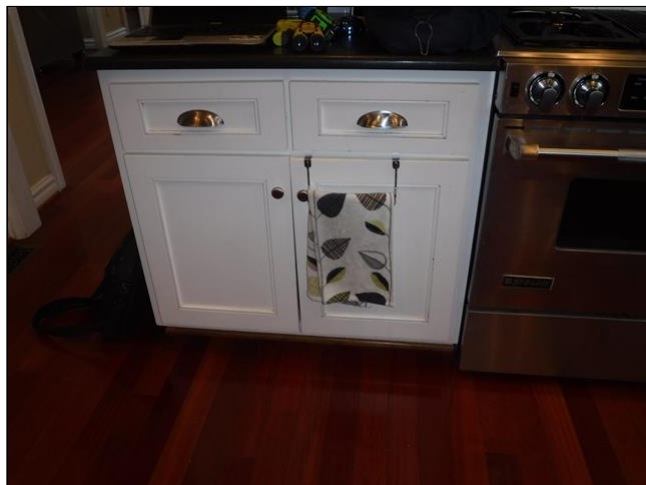
4.4 Item 1(Picture)

Cabinet door (s) need adjustment in a few locations . This is a cosmetic issue for your information. Recommend repair or replace as necessary.

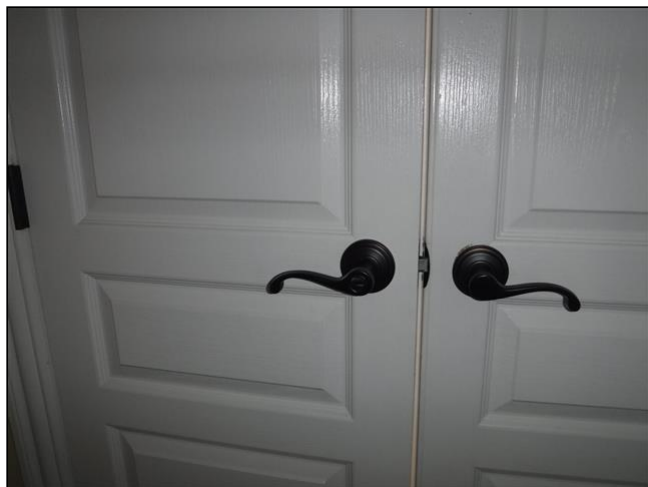
4.5 Item 1(Picture)

The Entry door needs strike and latch adjustment to shut tight at the Master Bedroom. This is a maintenance issue and is for your information. A qualified person should repair or replace as needed.

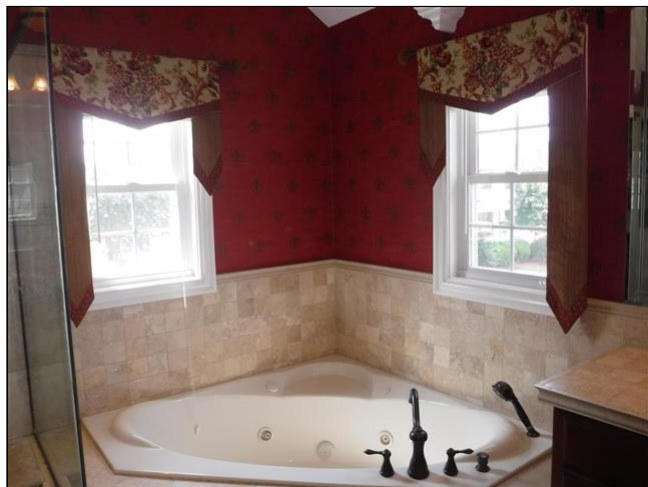
4.6 Item 1(Picture)

Two windows is/are not tempered glass at the Master bath. Non-tempered glass in or over a tub or shower is a safety issue . . . A qualified contractor should inspect and repair as needed.

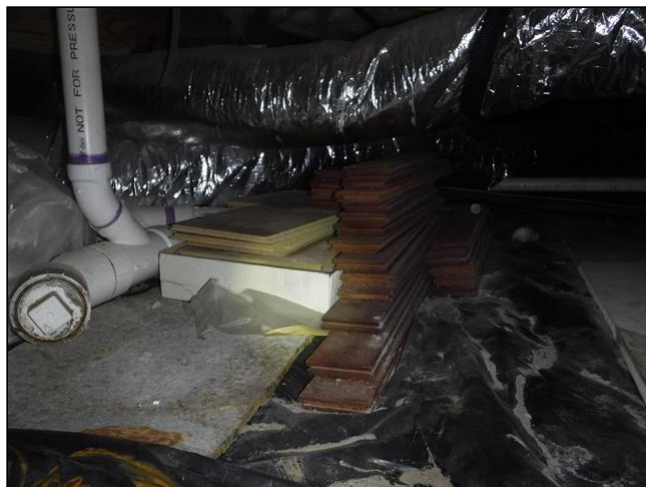
5.0 Item 1(Picture)

The construction debris needs removing from the crawlspace under home.

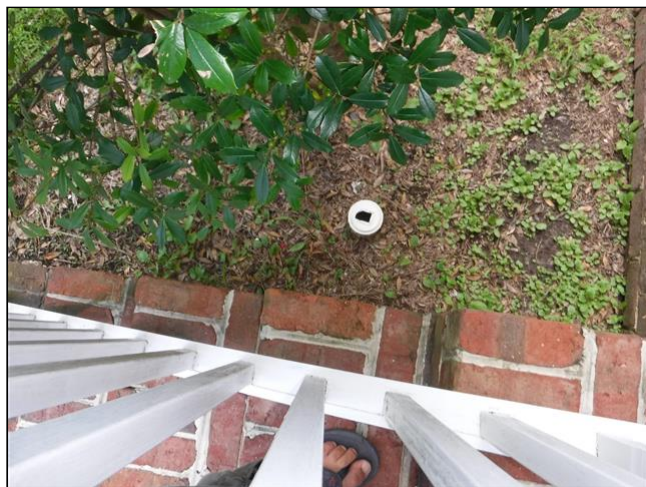
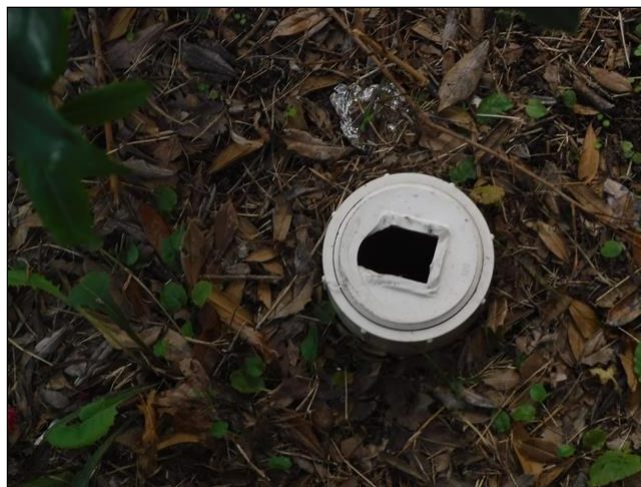
6.0 Item 1(Picture)

(1) The plumbing waste line Clean out cover is damaged in the front yard . This is not considered up to today's standard. A qualified licensed plumber should repair or correct as needed.

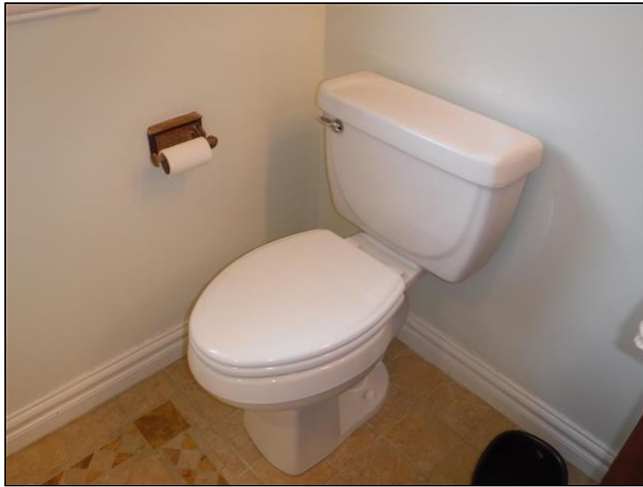
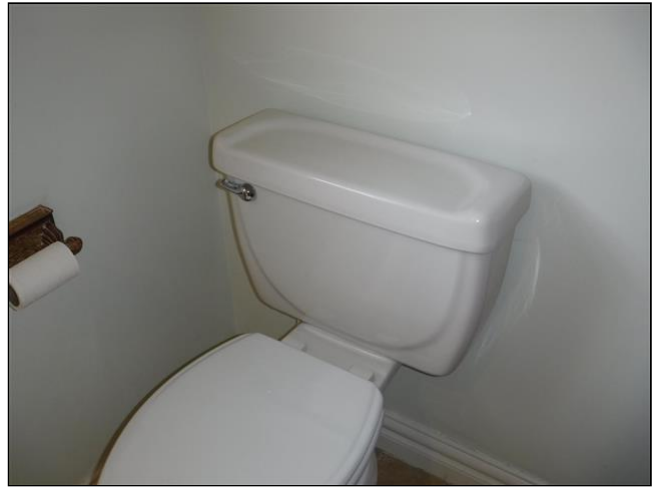
6.0 Item 3(Picture)

(2) The toilet is loose at floor and constantly runs, this is usually caused by a "bad" flapper valve at the hall bath. This is not considered up to today's standard. A qualified licensed plumber should repair or correct as needed.

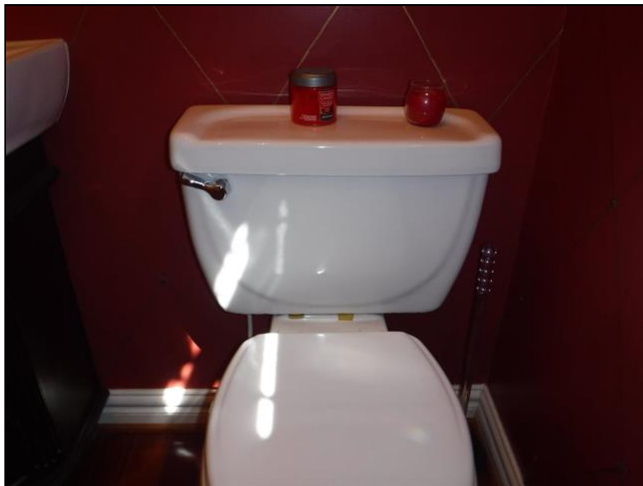
6.0 Item 5(Picture)

(3) The toilet tank is loose to the bowl at the half bath. This is not considered up to today's standard. A qualified licensed plumber should repair or correct as needed.

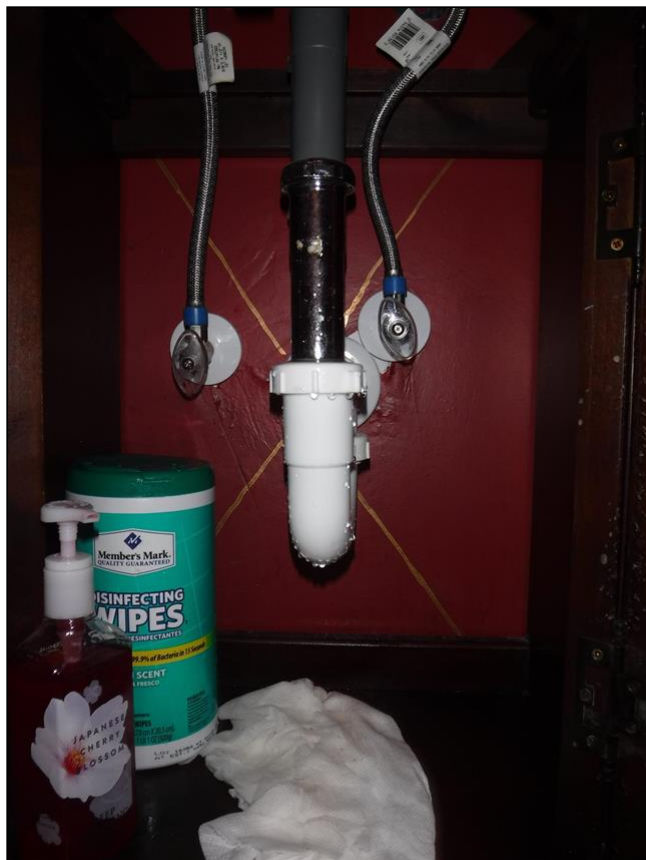
6.0 Item 6(Picture)

(4) The plumbing waste line leaks (under sink) in the half bath . This is not considered up to today's standard. Repairs are needed to stop leaking water from damaging the cabinet bottom or to eliminate moisture that may contribute to fungi growth. A qualified licensed plumber should repair or correct as needed.

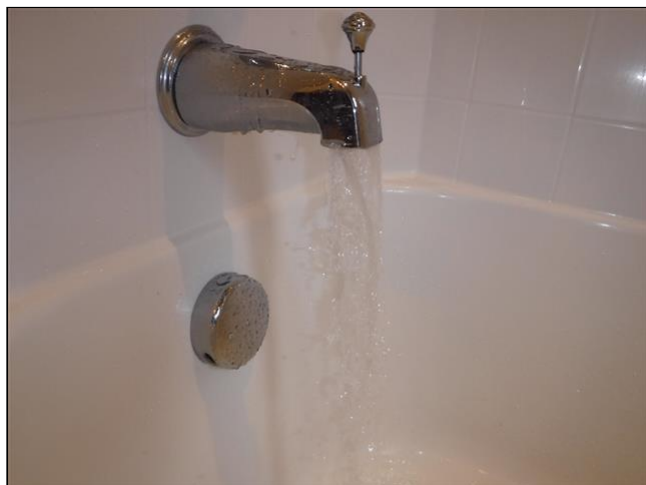
6.1 Item 1(Picture)

The tub spout diverter leaks a stream through tub spout when shower is on at the hall bath. This is not considered up to today's standard, this can also greatly affect water pressure to the shower. A qualified licensed plumber should repair or correct as needed.

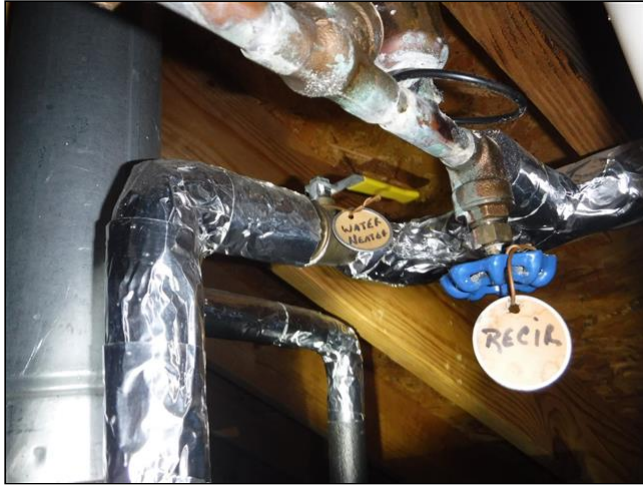
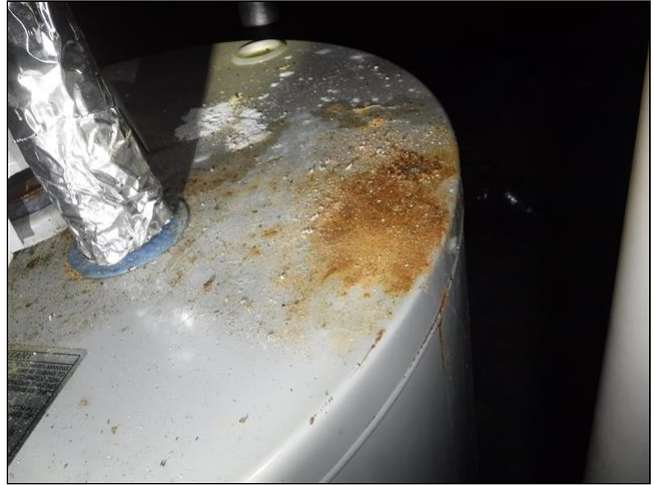
6.2 Item 1(Picture)

The water heater recirculation gate valve shows signs of a previous leak . It is not clear if this had been properly repaired . A qualified licensed plumber should repair or correct as needed.

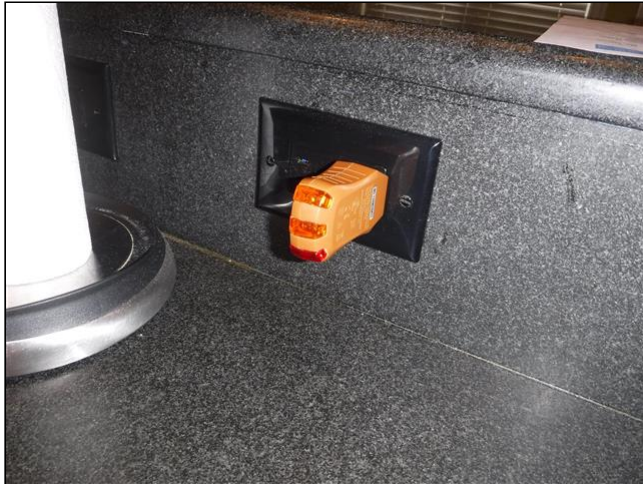
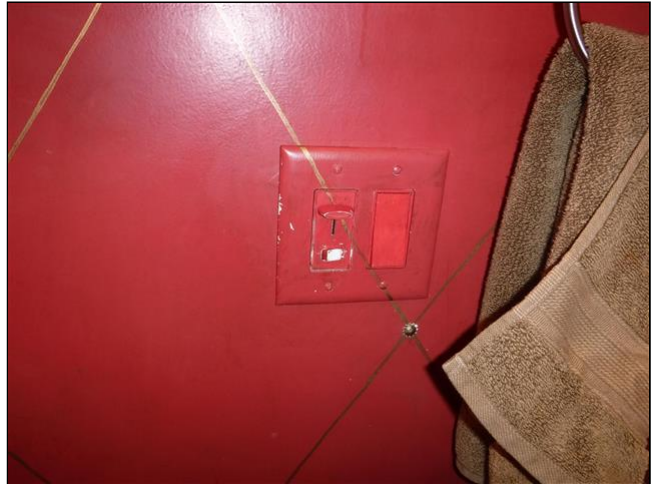
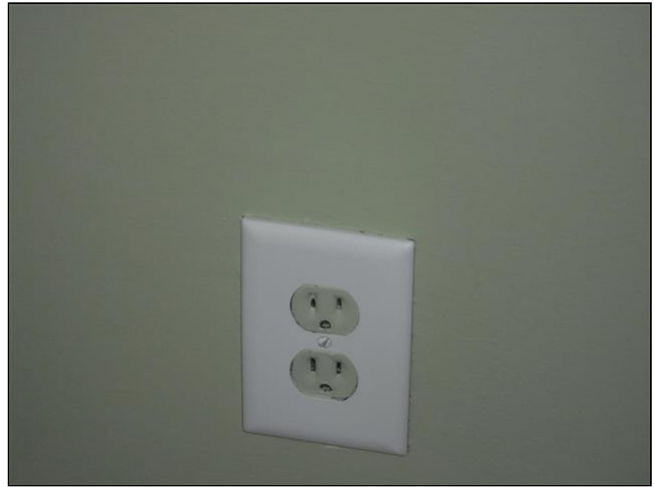
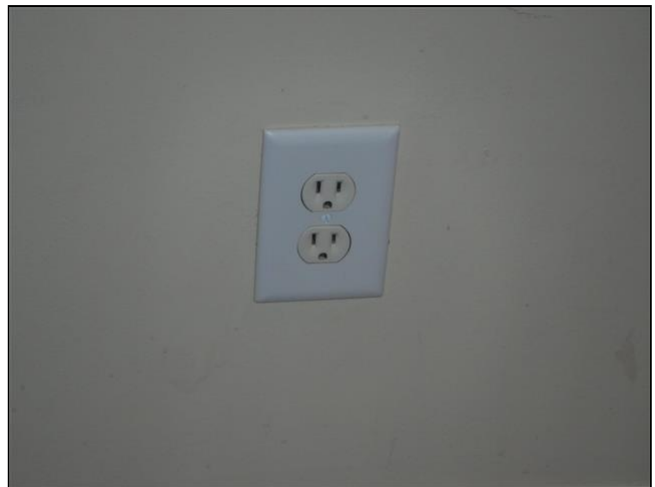
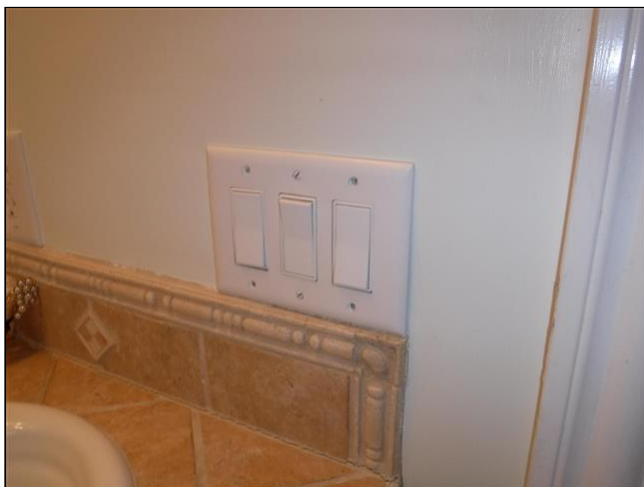
7.3 Item 1(Picture)

(1) Several switch(es) GFCI protected outlet(s) and "three-prong" outlets are loose in wall and need to be tightened. and or clogged or obstructed with paint or debris in most if not all rooms. This is a safety issue that needs to be corrected Further inspection is needed by a qualified licensed electrical contractor. A qualified licensed electrical contractor should perform repairs that involve wiring.

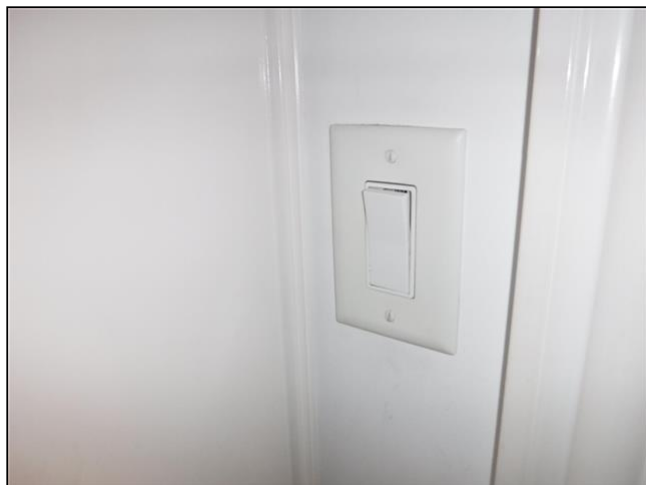
7.3 Item 8(Picture)

(2) The wall switch is broken (unsafe) at the Master Bedroom closet. This is a safety issue that needs to be corrected. A qualified licensed electrical contractor should perform repairs that involve wiring.

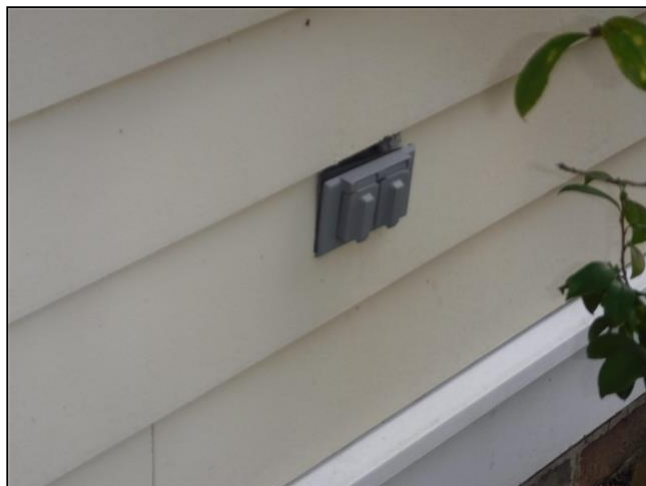
7.4 Item 1(Picture)

The exterior duplex outlet at the right side of home (facing front) is loose in the wall, and needs to be secured properly. This is a safety issue that needs to be corrected. Further inspection is needed by a qualified licensed electrical contractor. A qualified licensed electrical contractor should perform repairs that involve wiring.

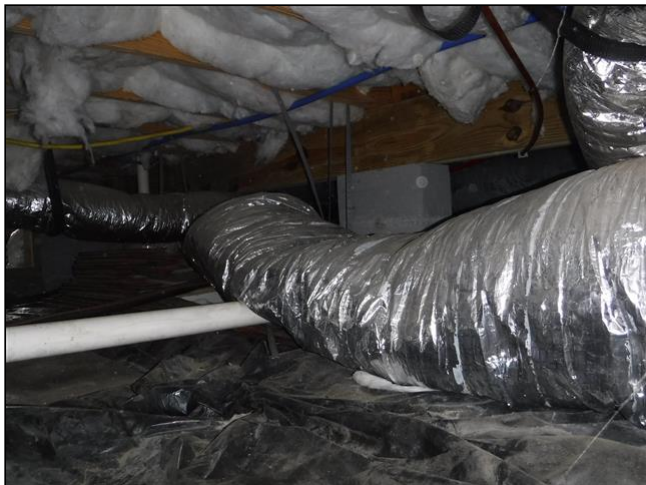
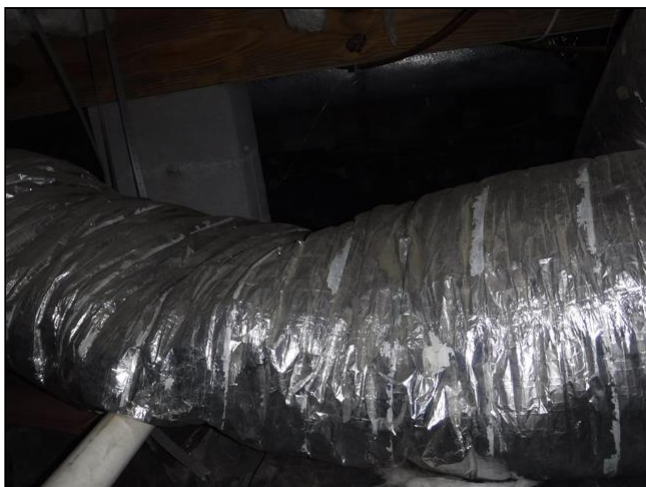
8.3 Item 1(Picture)

(1) The duct pipe is damaged in the crawlspace. Energy loss is occurring in crawlspace and immediate correction is needed. I recommend further inspection by a licensed HVAC contractor.

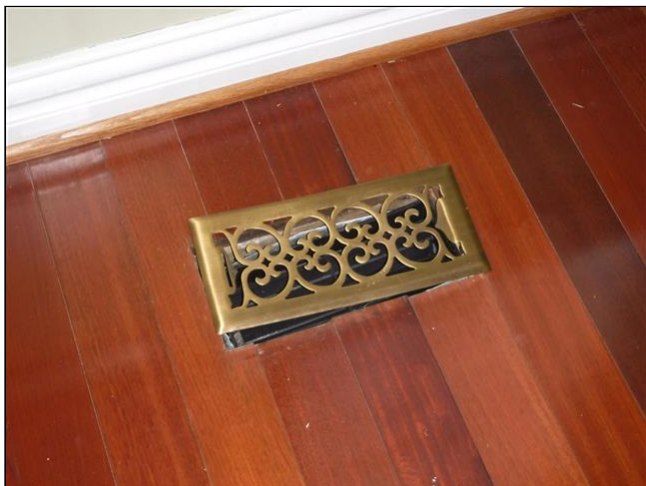
8.3 Item 4(Picture)

(2) The return air grill in floor is loose or is broken in a few locations on the lower level . This is a safety issue and should be repaired. A licensed HVAC contractor should service or repair unit.
