Inspection Report

Property Address:
1209 Godwin Ave
Norfolk Va 23455

Keff/Spec LLC

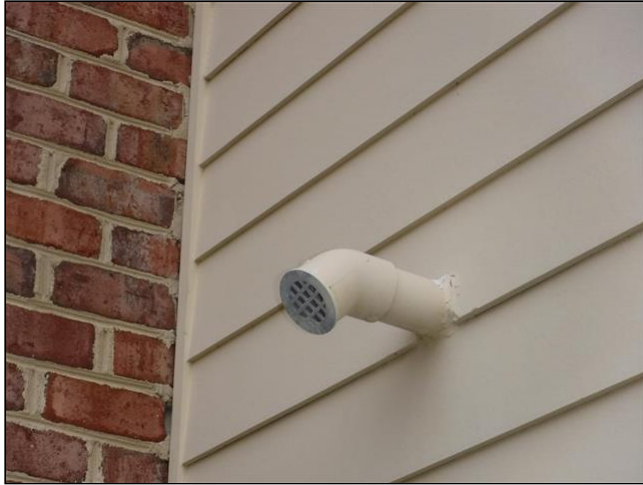
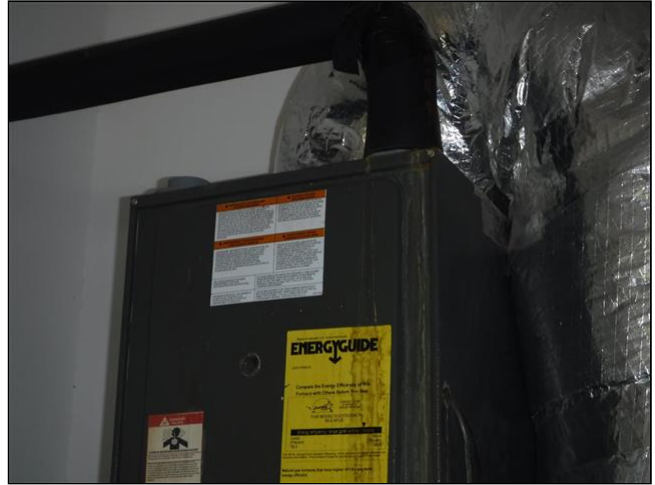
8.5 Item 1(Picture)

The vent pipe for gas furnace shows signs of a previous leak. at the exterior This repair dose not appear to be adequate . I recommend a qualified licensed heat contractor inspect further and repair as needed.

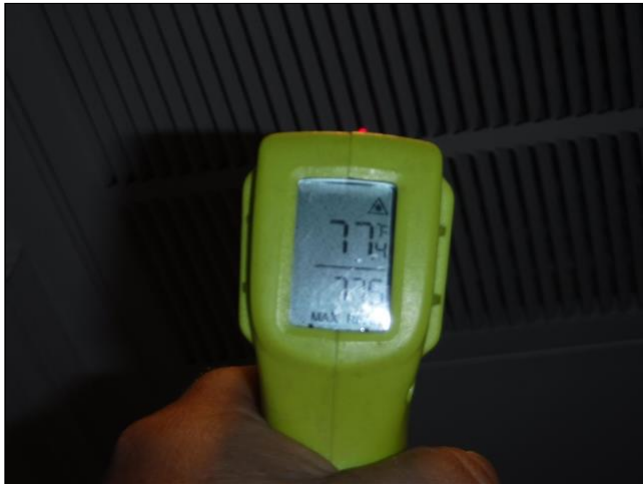
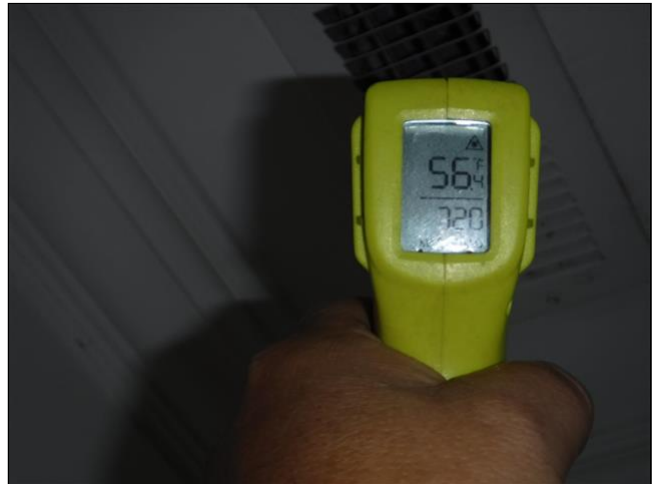
8.8 Item 1(Picture)

(1) The ambient air test was performed by using thermometers on the air handler of upper Air conditioner to determine if the difference in temperatures of the supply and return air are between 14 degrees and 22 degrees which indicates that the unit is cooling as intended. The supply air temperature on your system read 77 degrees, and the return air temperature was 56 degrees. This indicates that the unit is working well within the standards at this time ..

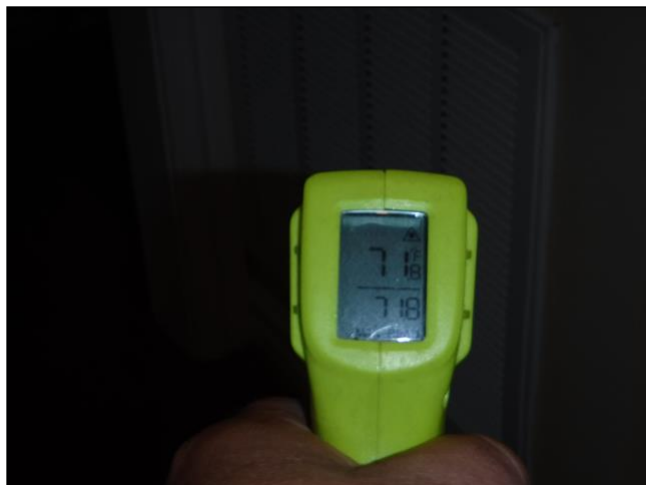
8.8 Item 3(Picture)

(2) The ambient air test was performed by using thermometers on the air handler of lower Air conditioner to determine if the difference in temperatures of the supply and return air are between 14 degrees and 22 degrees which indicates that the unit is cooling as intended. The supply air temperature on your system read 71 degrees, and the return air temperature was 57 degrees. This indicates that the unit is working well within the standards at this time ..

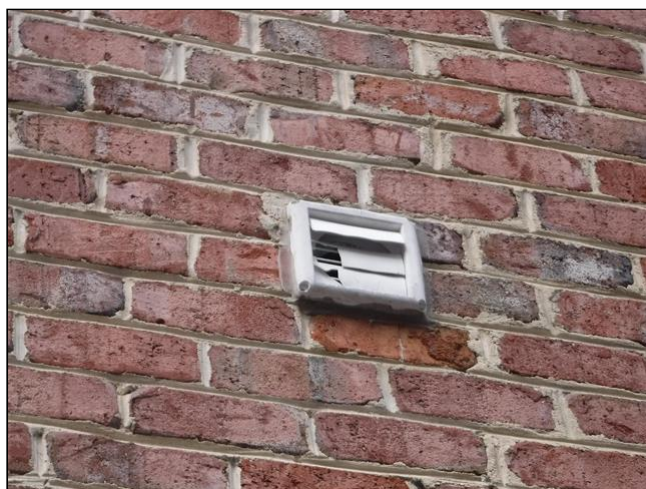
9.4 Item 1(Picture)

The Bathroom exhaust fan cover is damaged at the exterior at the left side of the home . This can allow access to birds and other animals. A qualified person should repair or replace as needed.

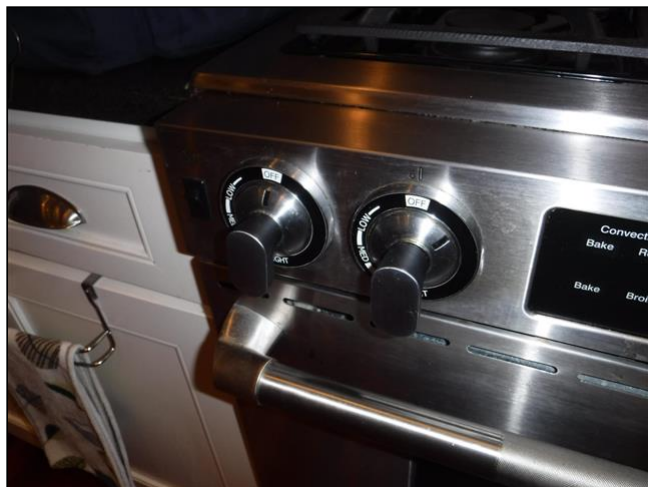
10.1 Item 1(Picture)

Control knob indicators do not line up properly . This is a cosmetic issue for your information
